INTERIM INSPECTION.

YARRA SHIRE COUNCIL

SITE ADDRESS: MONBULK ROAD SILVAN

PROJECT: PROPPING OF *Corymbia ficifolia*

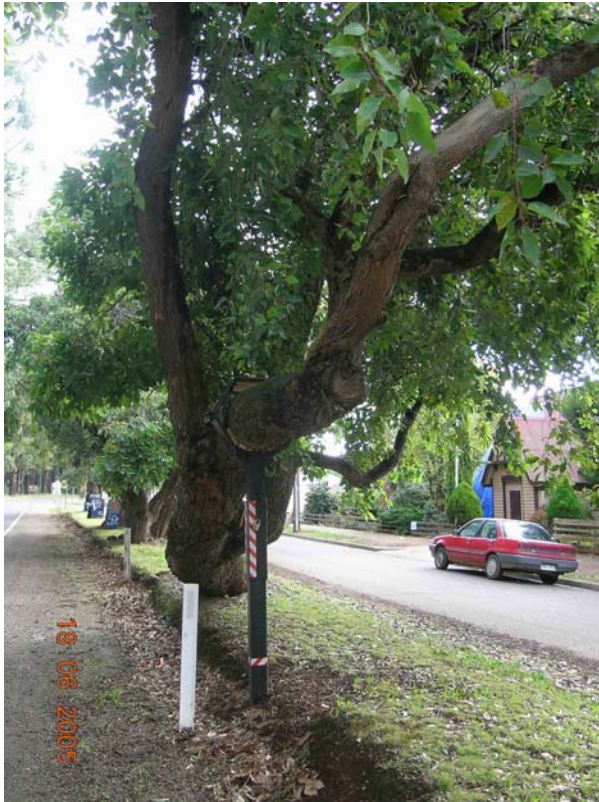
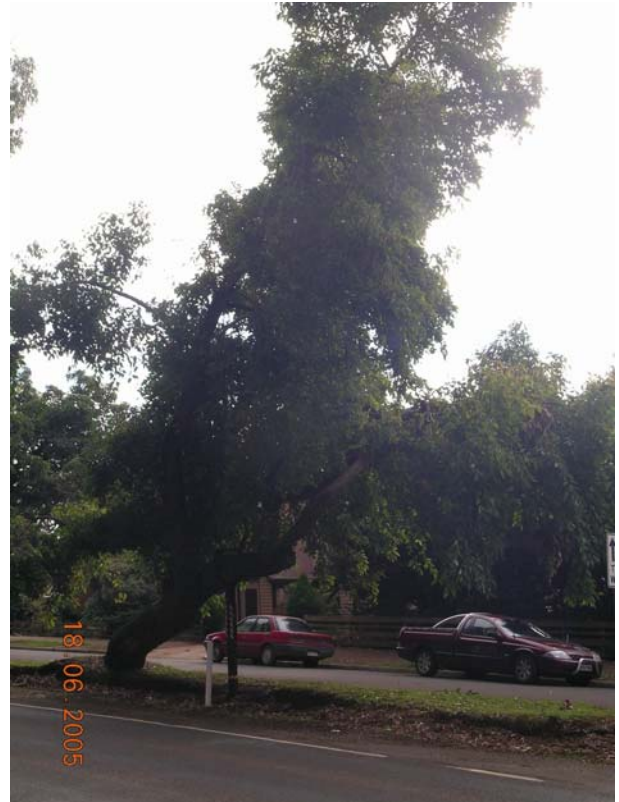
The interim inspection noted the following observations

1. There has been no movement in the props base plate since the installation.
2. When the installation of the prop occurred there was no weight on the prop, the adjustment pin could be easily turned. At this interim inspection it is noted that the pin cannot be turned and from a visual observation it is evident that the tree. The prop is now supporting the trees.
3. The headstock currently does not require adjustment; this will require adjustment in November 05. This will ensure no movement occurs when the fruit matures and increase the overall weight of the tree.
4. The marker post has been installed to ensure the grader cannot hit the submerged base plate.

1. An annual inspection in November of each year shall be organised by the Council for ENSPEC staff to inspect and make any adjustments to the propping system.
2. Keys to the adjustable locking system are to be held by the council.
3. If any disturbance of the propping system is noted then ENSPEC are to be notified as soon as possible to assess the tree and propping system.
4. Council's arborist should undertake an annual Visual Tree Assessment of the tree in October of each year.
